Contract #: 04-0120F4Cty: SF/ALA Rte: 80 PM: 13.2/13.9File #: 69.28**WELDING INSPECTION REPORT****Resident Engineer:**Pursell, Gary**Address:** 333 Burma Road**City:** Oakland, CA 94607**Report No:** WIR-012924**Date Inspected:** 17-Mar-2010**Project Name:** SAS Superstructure**OSM Arrival Time:** 700**Prime Contractor:** American Bridge/Fluor Enterprises, a JV**OSM Departure Time:** 1900**Contractor:** Zhenhua Port Machinery Company, Ltd (ZPMC), Changxing Island **Location:** Shanghai,China**CWI Name:** Mr.Li Lin**CWI Present:** Yes No**Inspected CWI report:** Yes No N/A**Rod Oven in Use:** Yes No N/A**Electrode to specification:** Yes No N/A**Weld Procedures Followed:** Yes No N/A**Qualified Welders:** Yes No N/A**Verified Joint Fit-up:** Yes No N/A**Approved Drawings:** Yes No N/A**Approved WPS:** Yes No N/A**Delayed / Cancelled:** Yes No N/A**Bridge No:** 34-0006**Component:** Tower**Summary of Items Observed:**

WELDING INSPECTION REPORT

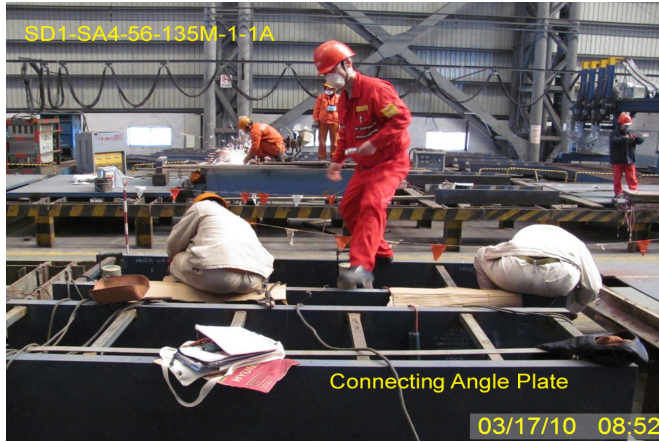
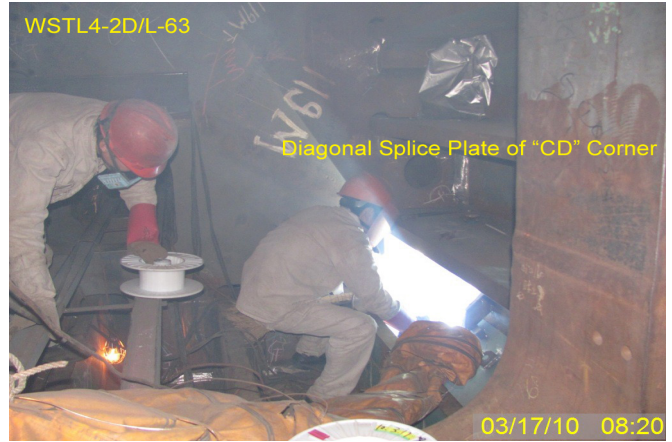
This QA inspector observed the following work in progress:

FCAW welding of weld joint no: WSTL4-2D/L-63 located on Diagonal Splice Plate of “CD” Corner. Welder is identified as 053316.ZPMC CWI is identified as Mr.Li Lin. The welding variables recorded by QC appeared to comply with the WPS-B-T-2233-B-U2a-F-1.
